DETECTION OF CRACKS ADJACENT TO SPOTWELDS BY  
RADIOGRAPHY IN THIN STAINLESS STEEL SHEET

MRG - 289

January 29, 1962

GENERAL DYNAMICS/CONVAIR

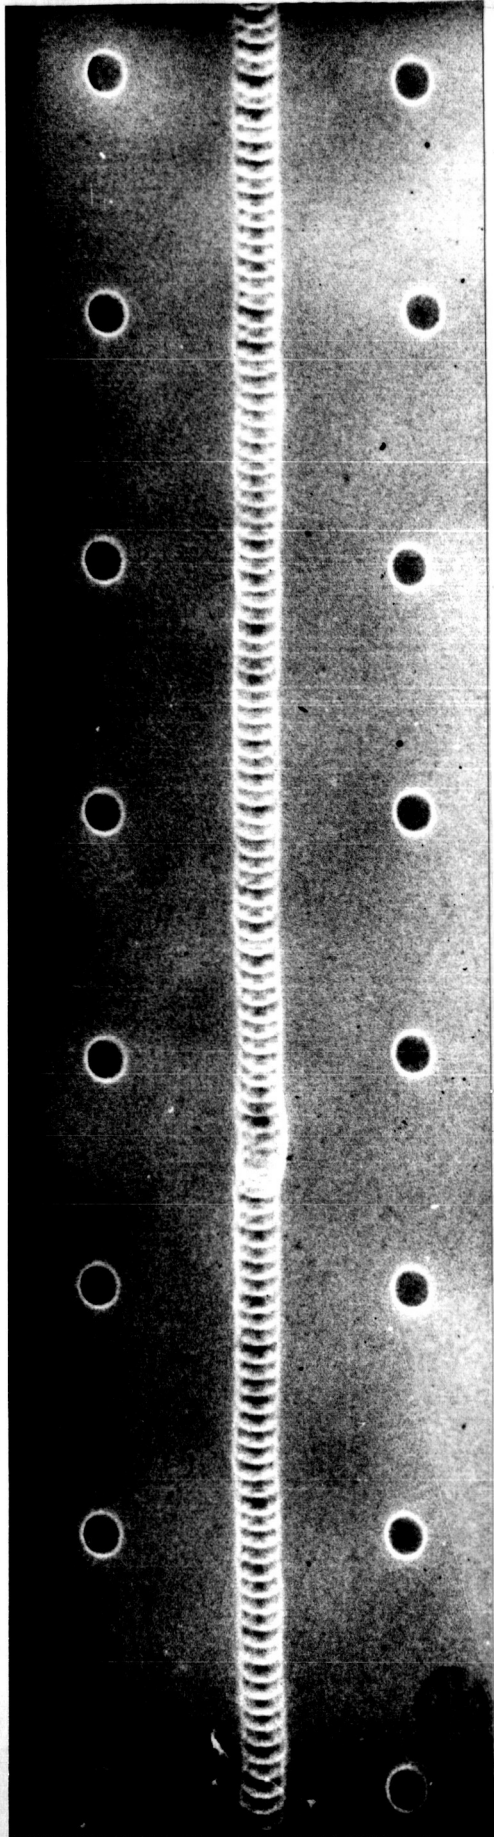
FIGURE 1 - Enlargement (approx. 2.4X) of the radiograph of the weld joint configuration of the fatigue specimen fabricated from 301 half hard, Ht. No. B87L24. This print was made so that it appears as if the actual radiograph is being observed (black is black and white is white). The cracks can be seen as black crescent shaped areas on the upper periphery of the spotweld nuggets, top row. (Nos. 1, 2, 3, etc.)

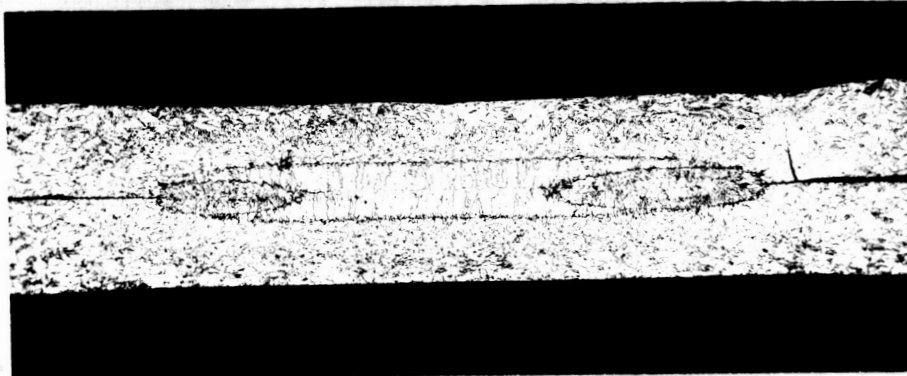
FIGURE 2 - Cross-sectional view thru the centerline of spot weld No. 2 (see Fig. 1). Note the secondary weld nugget which is the result of extended welding time when a pulsating current resistance spot weld machine is used. The fatigue load was applied to the top sheet and directed to the right. This crack was detected by radiography.

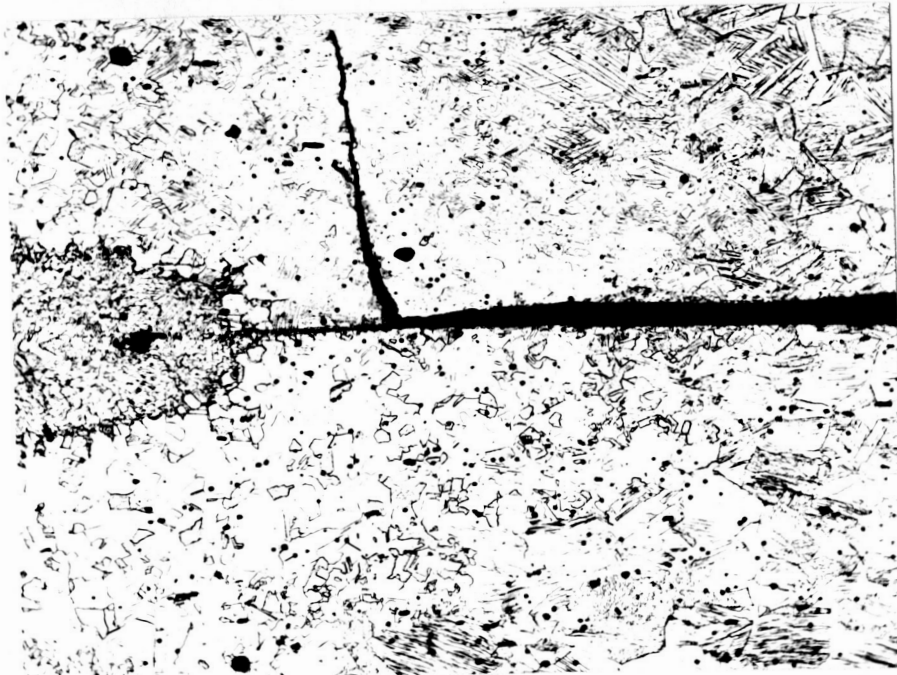
FIGURE 3 - Same spot weld as above except at a higher magnification to show the fatigue crack in greater detail. The crack length is 0.006" or 65% thru the sheet thickness.

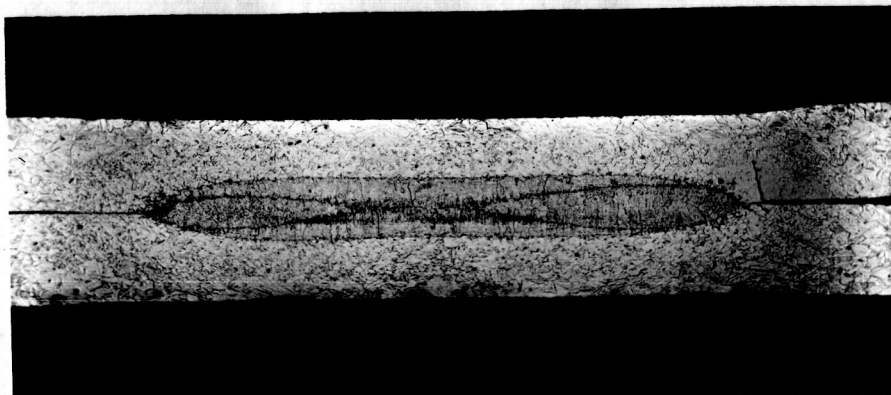
FIGURE 4 - Cross-sectional view thru the centerline of spot weld No. 4 (see Figure 1). The load was applied to the top sheet and directed to the right. Radiographic inspection detected a slight indication of a crack.

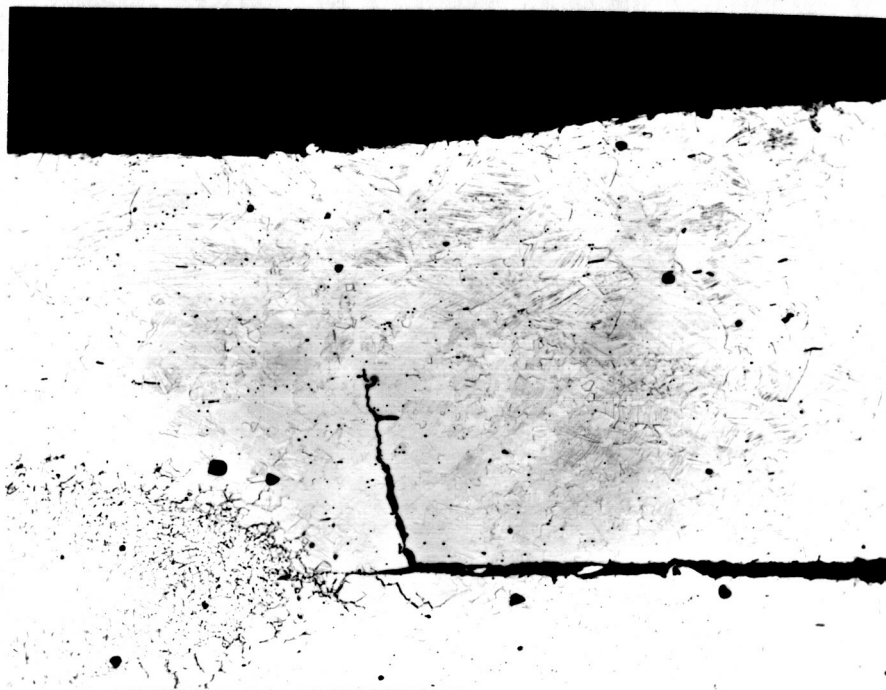
FIGURE 5 - Same spot weld as shown in Fig. 4 except at a higher magnification to show the fatigue crack in greater detail. The crack length is 0.004" or 46% of the sheet thickness.

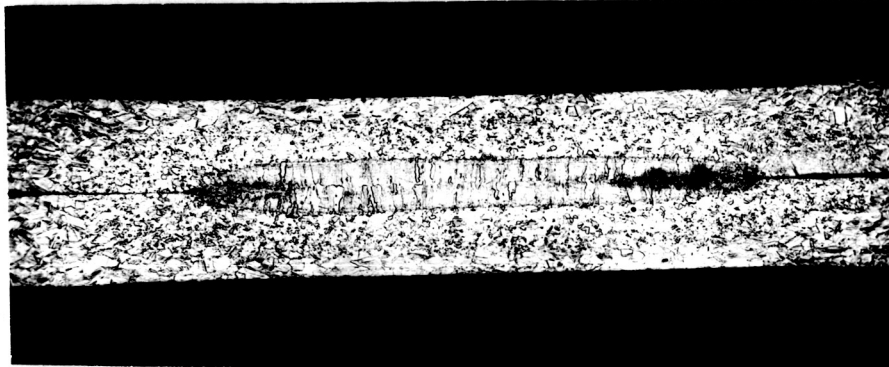
FIGURE 6 - Cross-sectional view thru the centerline of spot weld No. 5 (see Fig. 1). The load was applied to the top sheet and directed to the right. The four fine cracks are not readily visible in this photomicrograph (see Fig. 7). Radiographic inspection detected a slight indication of a crack.

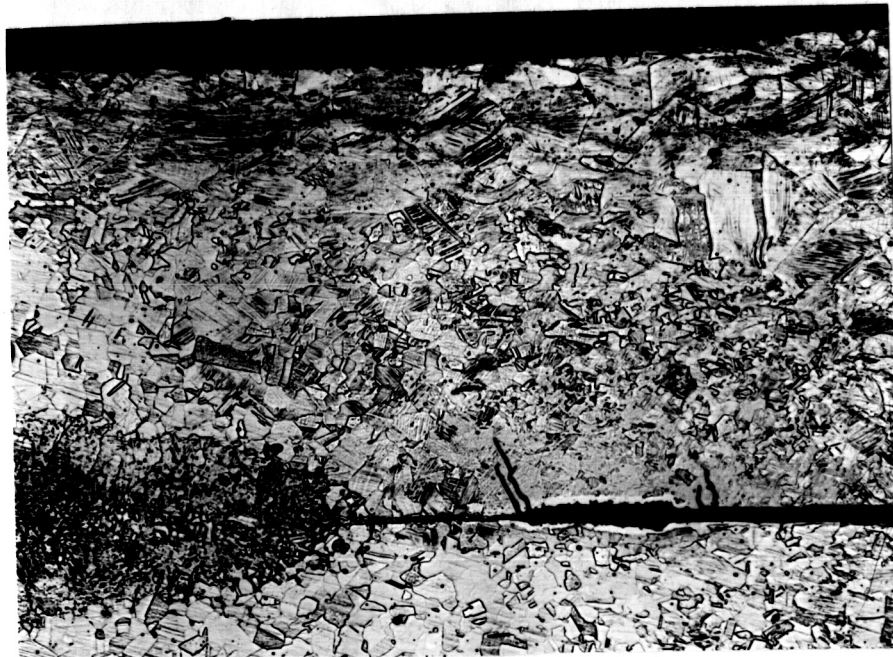
FIGURE 7 - Same spot weld as shown in Figure 6 except at a higher magnification so that the four fine cracks are made visible. The shortest crack is 0.0005" while the longest crack is 0.0015" (respectively 5% and 16% thru the sheet thickness).

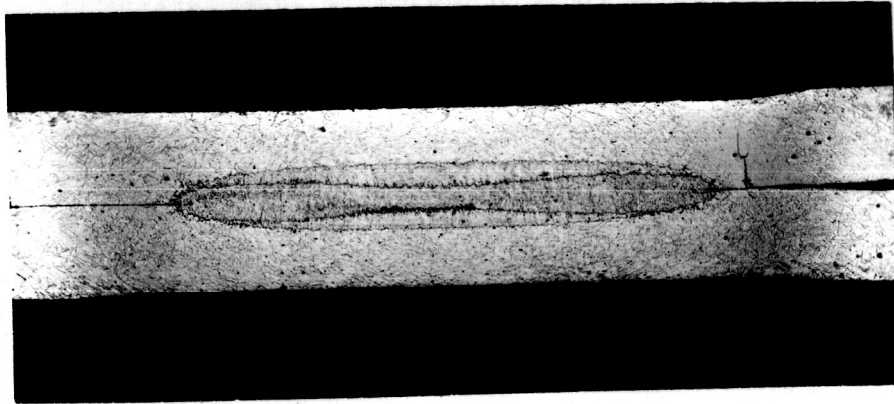
FIGURE 8 - Cross-sectional view thru the centerline of spot weld No. 6 (see Fig. 1). The load was applied to the top sheet and directed to the right. Radiographic inspection detected a crack.

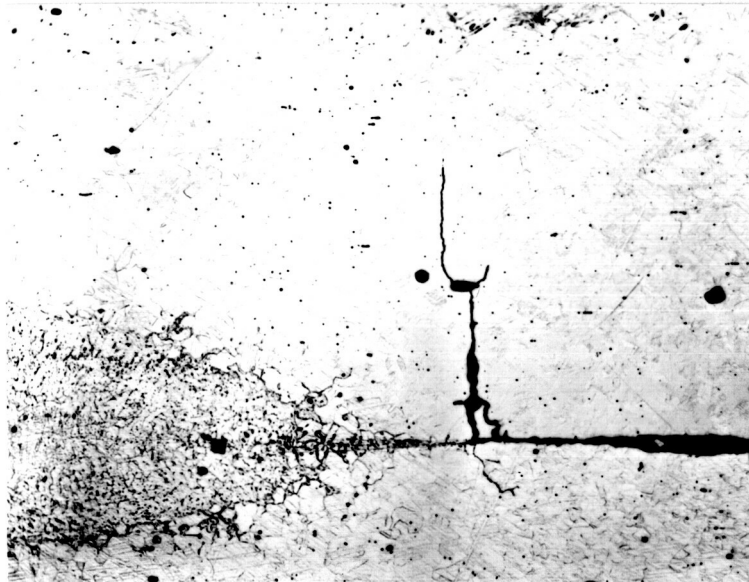
FIGURE 9 - Same spot weld as shown in Fig. 8 except at a higher magnification. The crack length is 0.0056 or 61% of the sheet thickness. Note that as the crack propagated thru the load sheet, it branched into two parts at an inclusion. Note also that a fine crack is present in the unloaded sheet. This fine crack appears to be a continuation of the major crack in the loaded sheet.

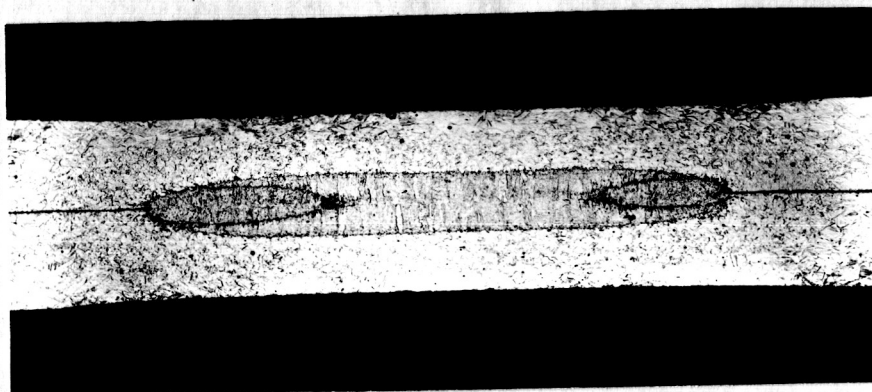
FIGURE 10: Cross-sectional view thru the centerline of spot weld No. 9 (see Fig. 1). The load was applied to the top sheet and directed to the right. No crack is present. Radiographic inspection did not detect a crack.

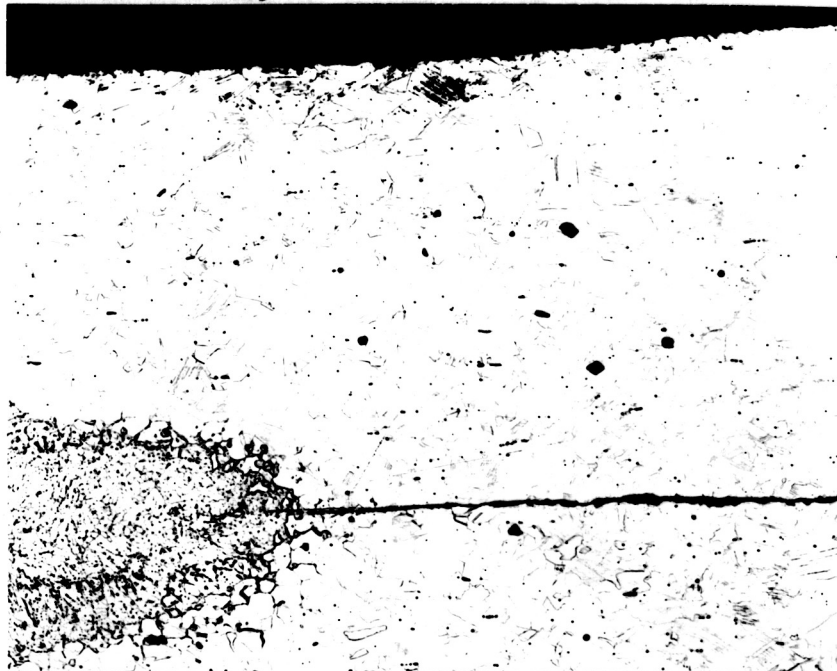
FIGURE 11 - Same spot weld as show in Fig. 10 except the area where the fatigue cracks would occur is shown at a higher magnification. Load was applied to the top sheet and directed to the right.

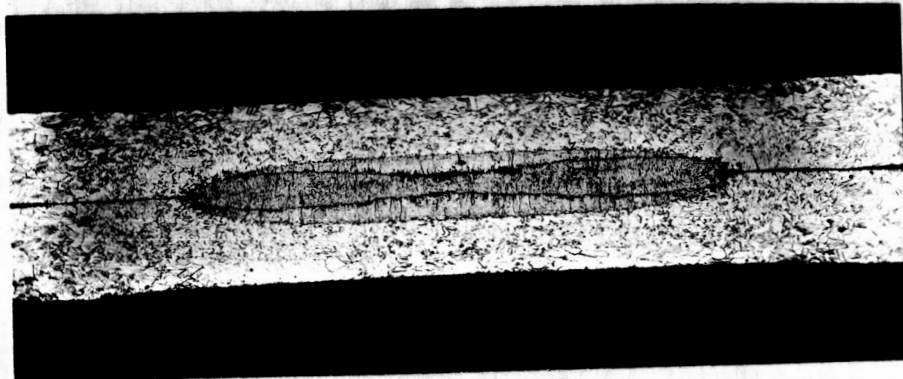
FIGURE 12 - Cross-sectional view thru the centerline of spot weld No. 12 (see Fig. 1). The load was applied to the top sheet and directed to the right. Radiographic inspection did not detect a crack.

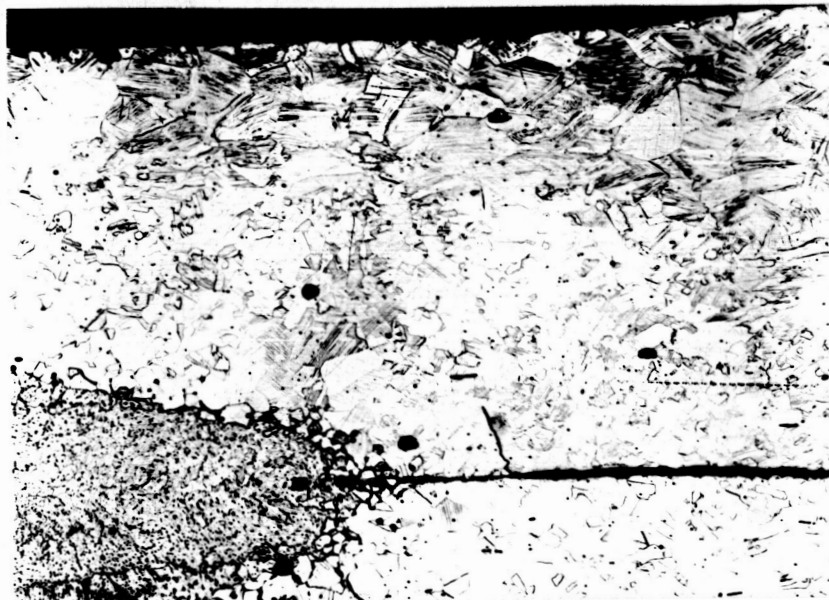
FIGURE 13:- Same spot weld as shown in Fig. 12 except at a higher magnification so that the fatigue crack is made visible. The crack length is 0.0014" or 15% of the sheet thickness.
